Crawl Space Research

Managing moisture and saving energy with closed crawl spaces

Cyrus Dastur

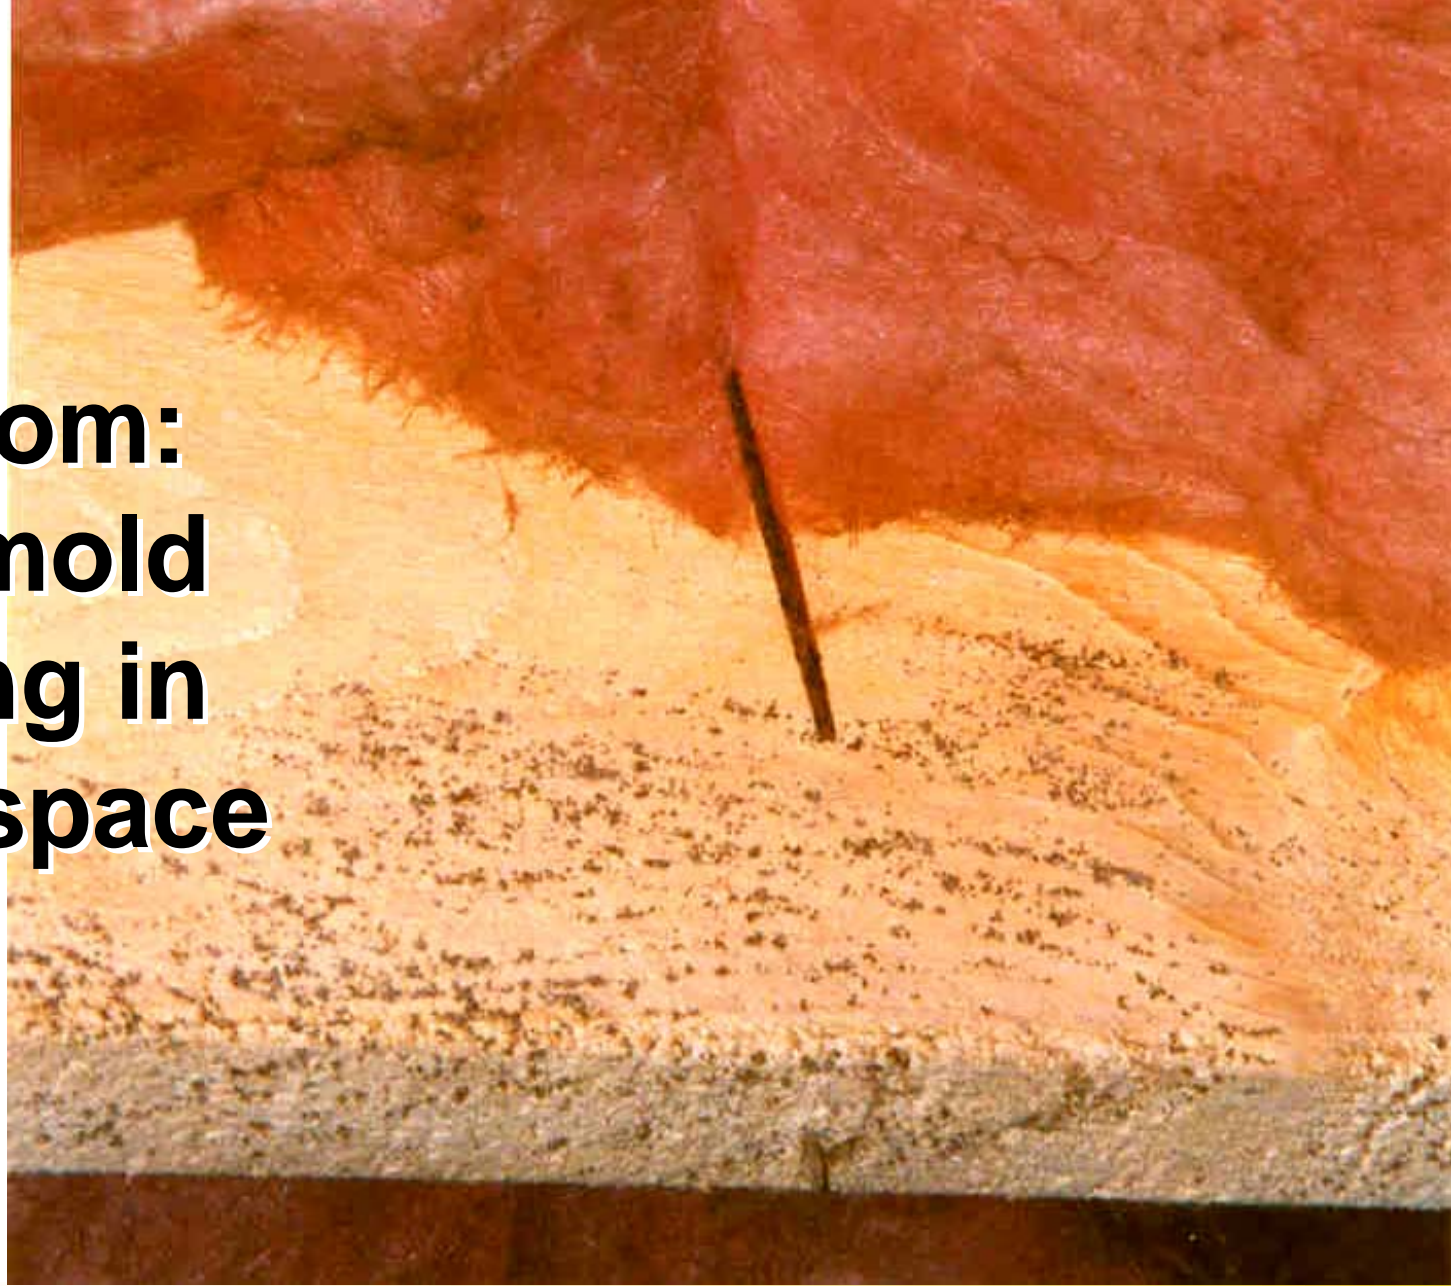
**Symptom:
Light mold
spotting in
crawl space**

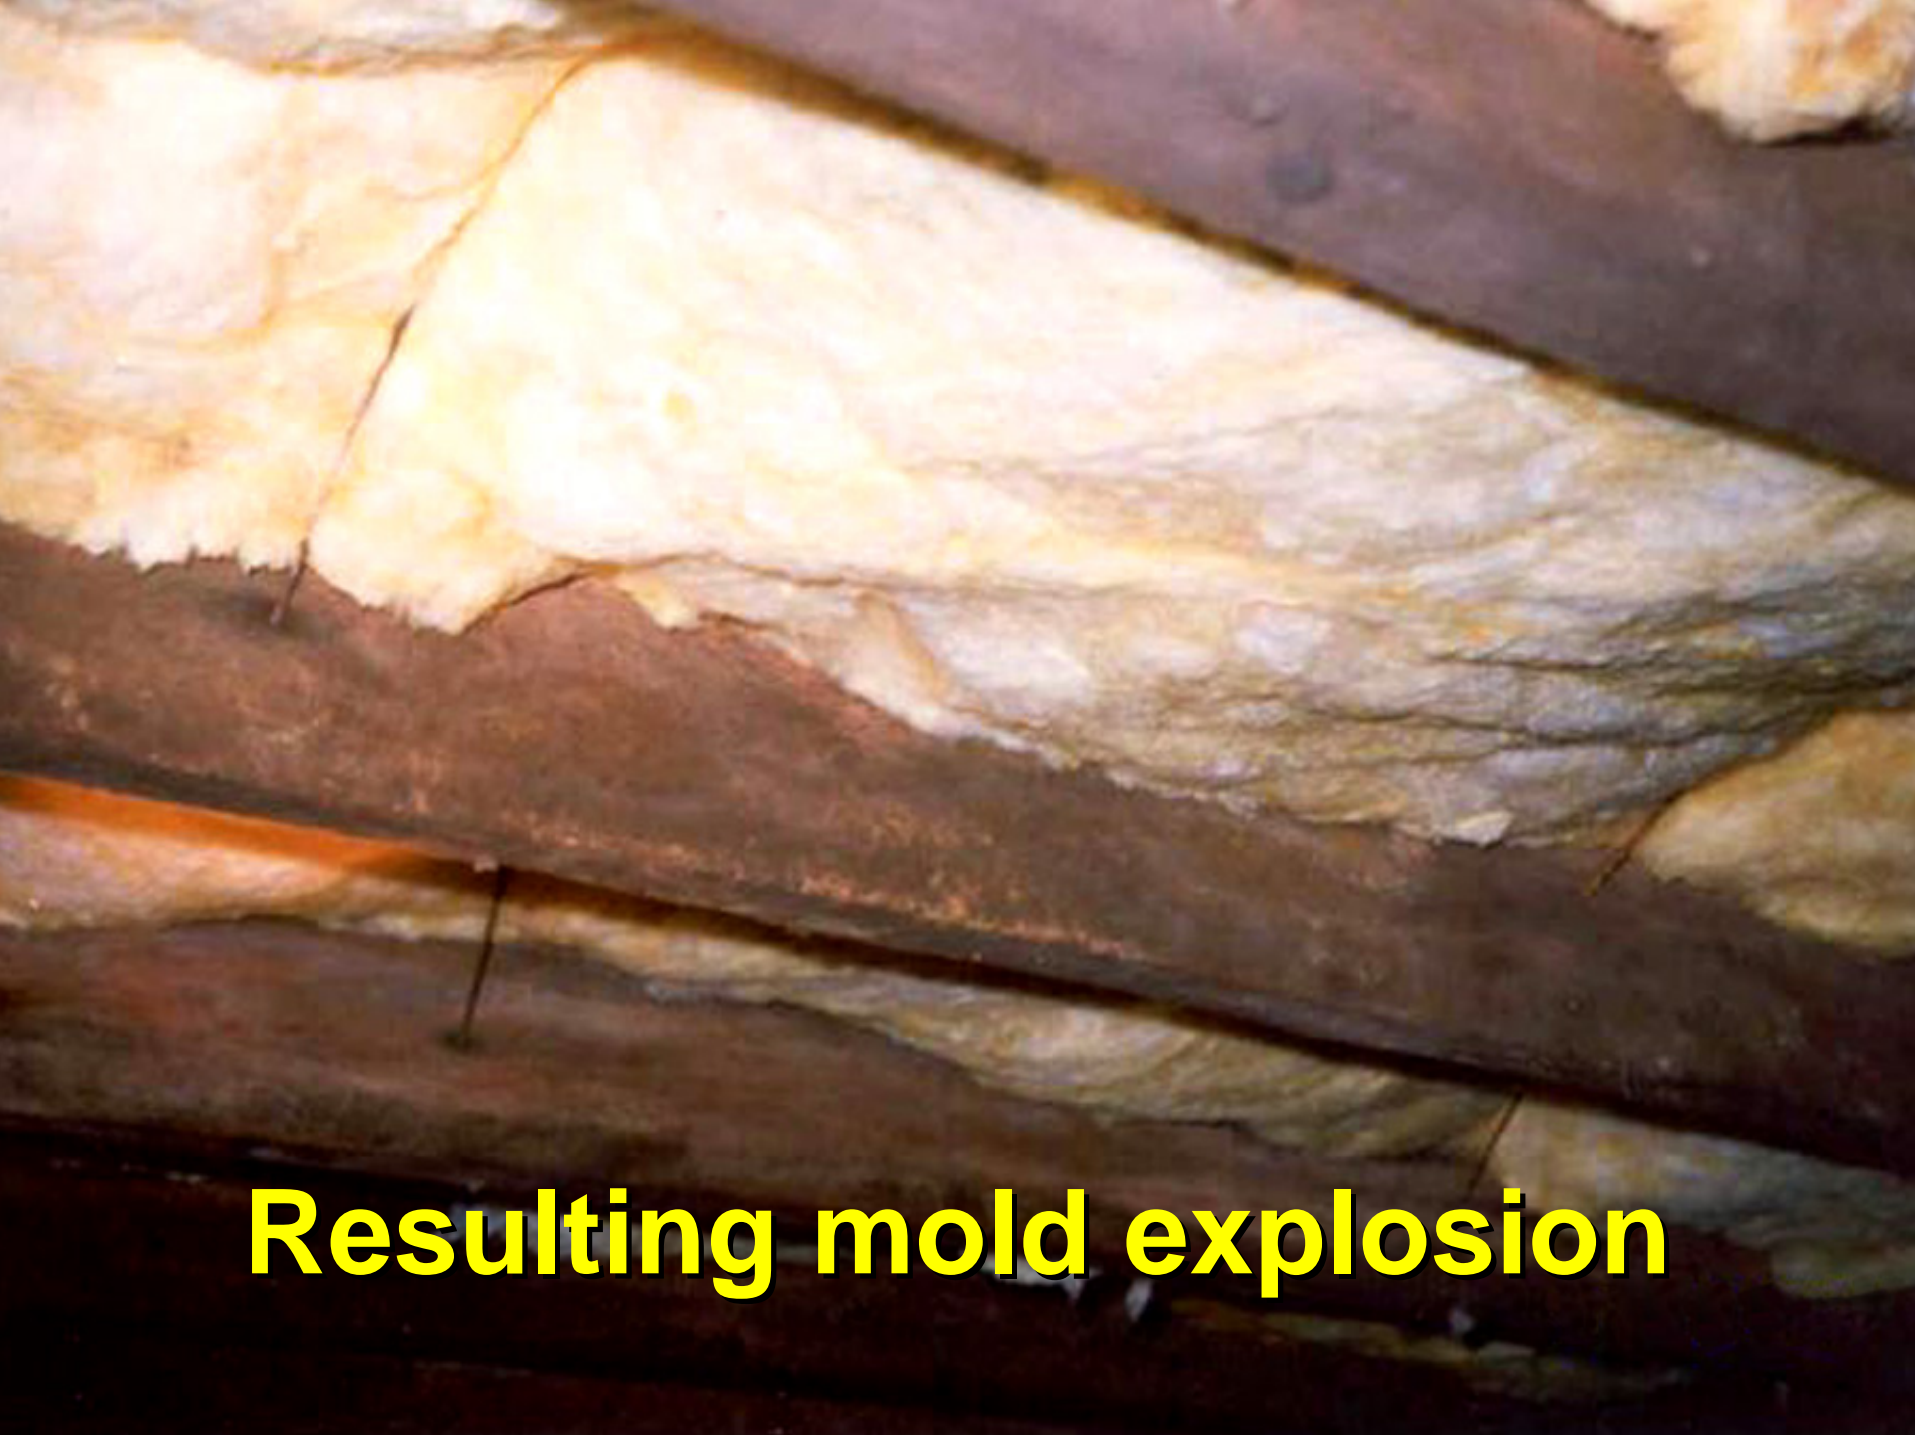
Resulting mold explosion

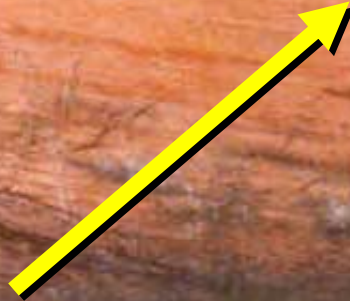
A red Swiss Army knife is shown stuck into a piece of wood. The knife is oriented vertically, with the handle at the top and the blade pointing downwards. The wood is light brown and shows signs of decay or rot, particularly in the area where the knife is inserted. A small, dark, irregular piece of wood has just been removed from the wood's surface by the tip of the knife, illustrating the concept of rot.

**Some
lumber
rotten**

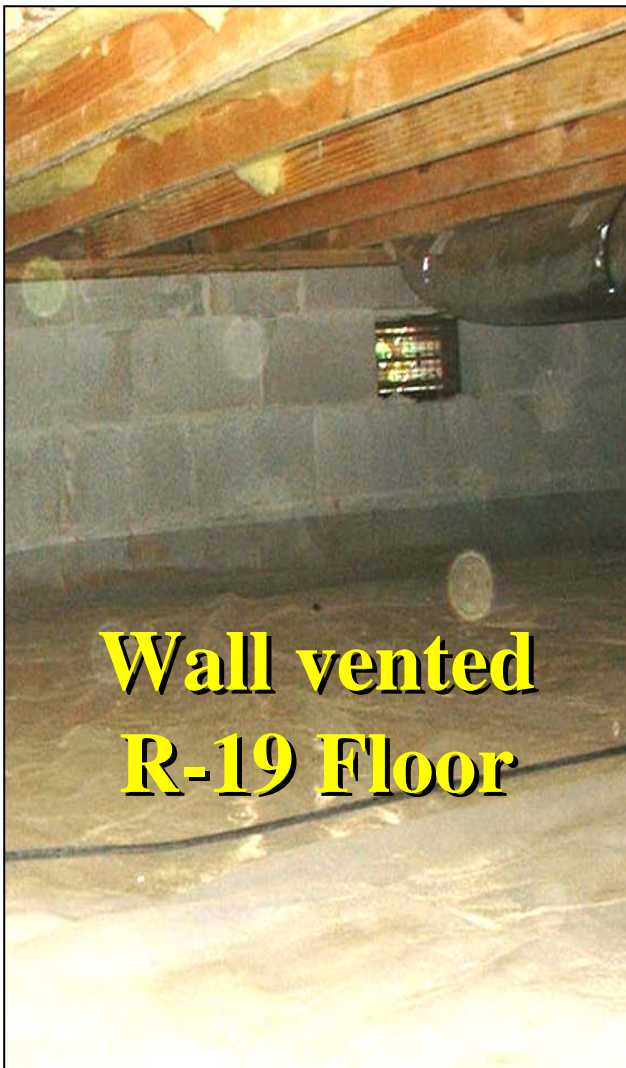
**Wall vented
R-19 Floor**

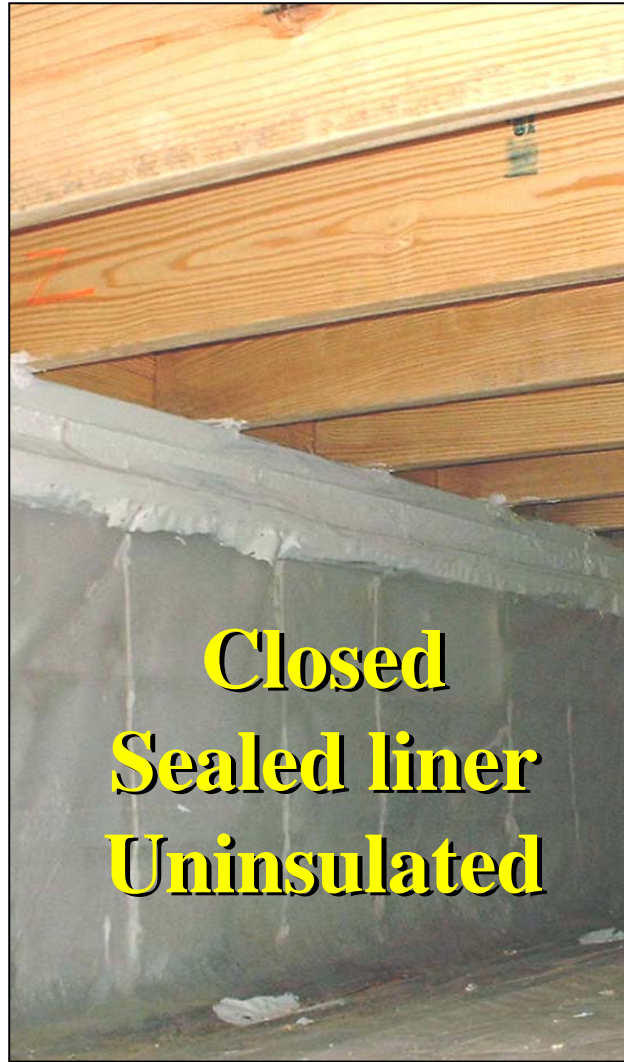
**Closed
Sealed liner
Uninsulated**

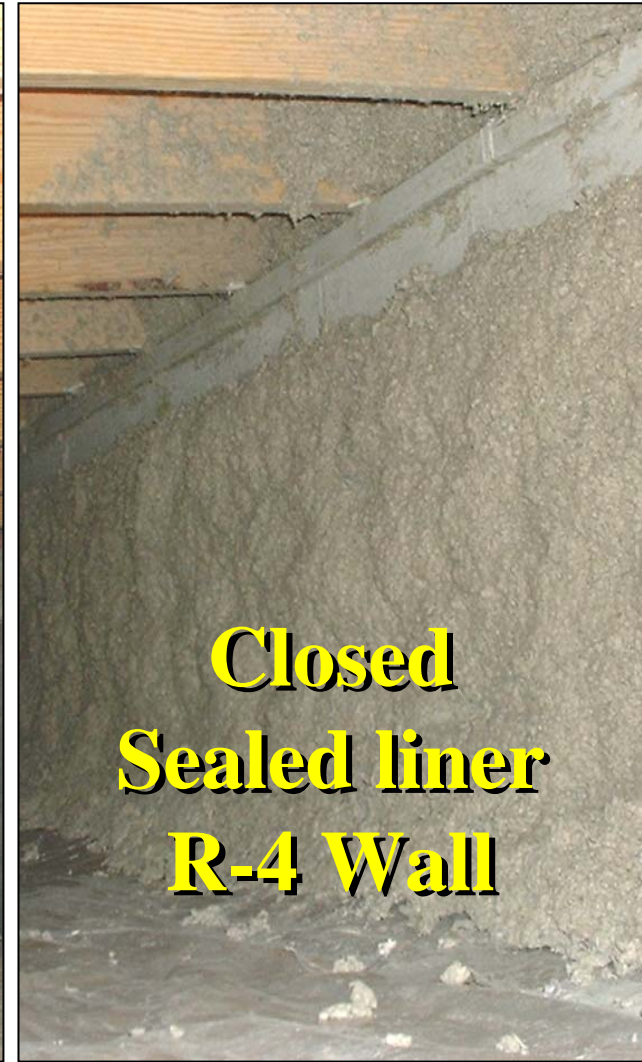
**Closed
Sealed liner
R-4 Wall**

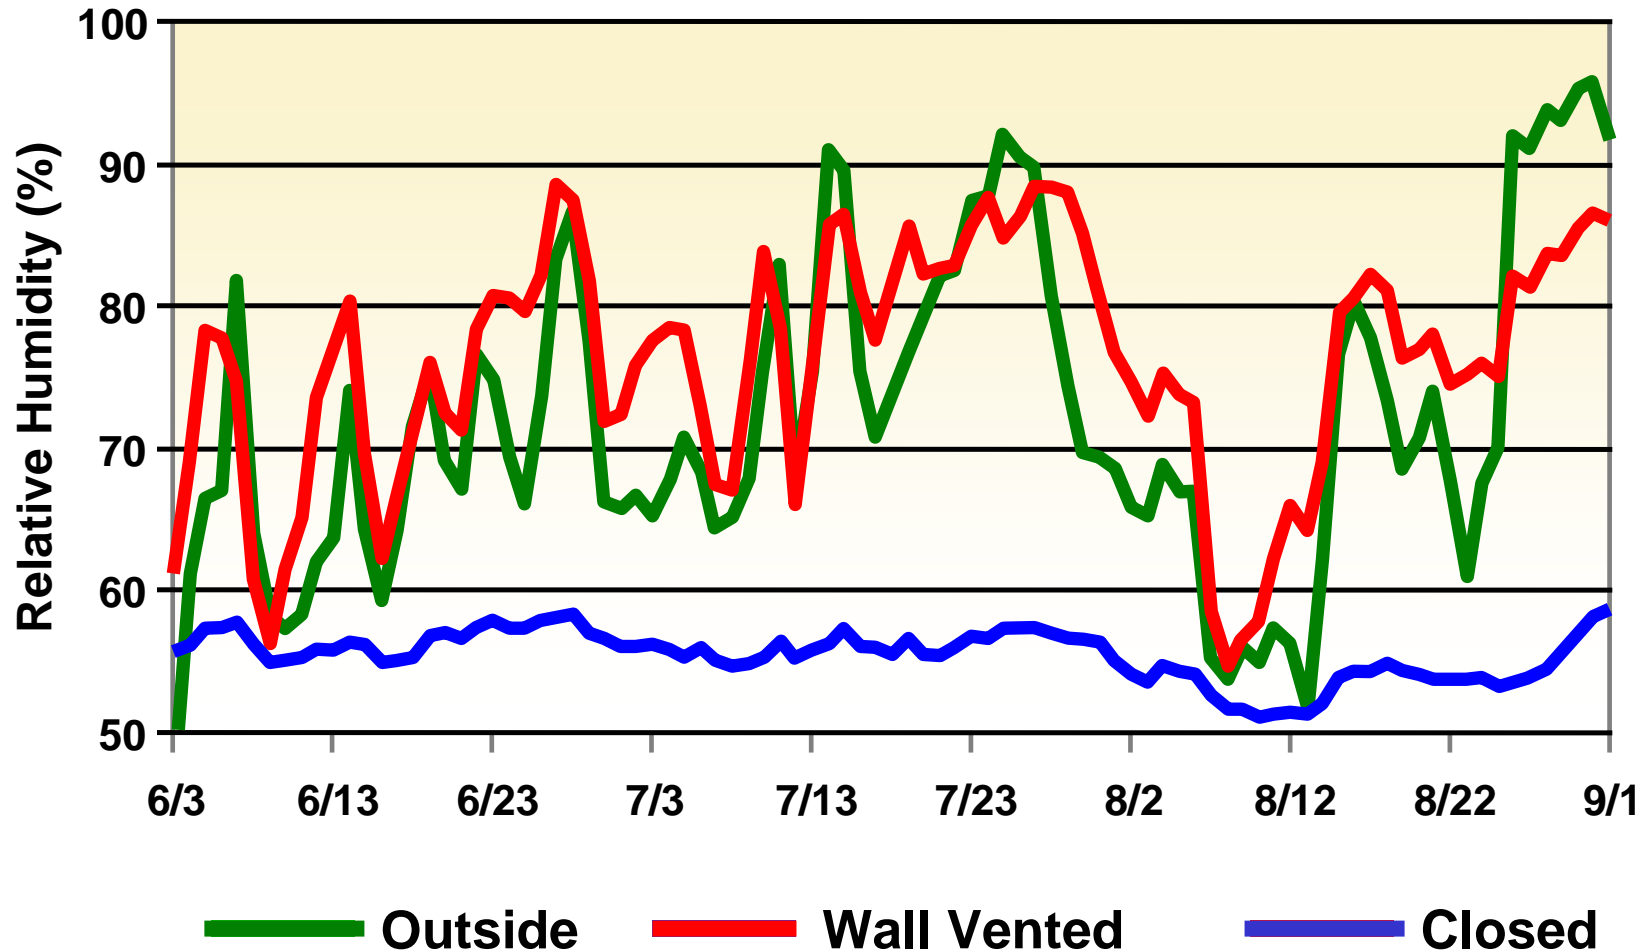
Phase I Crawl Space Relative Humidity

- **Humidity was controlled in closed crawl spaces and not controlled in wall-vented crawl spaces**
- **Utility bill analysis indicated that the closed crawl space houses might be saving energy on heating and cooling (even with 4 uninsulated homes!).**

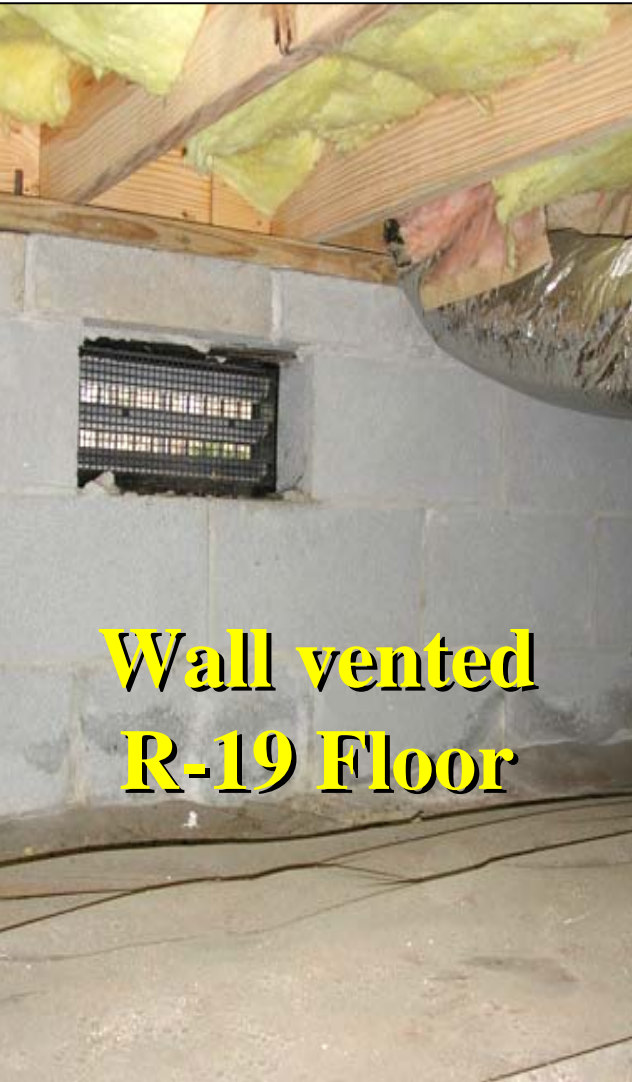
**Wall vented
R-19 Floor**

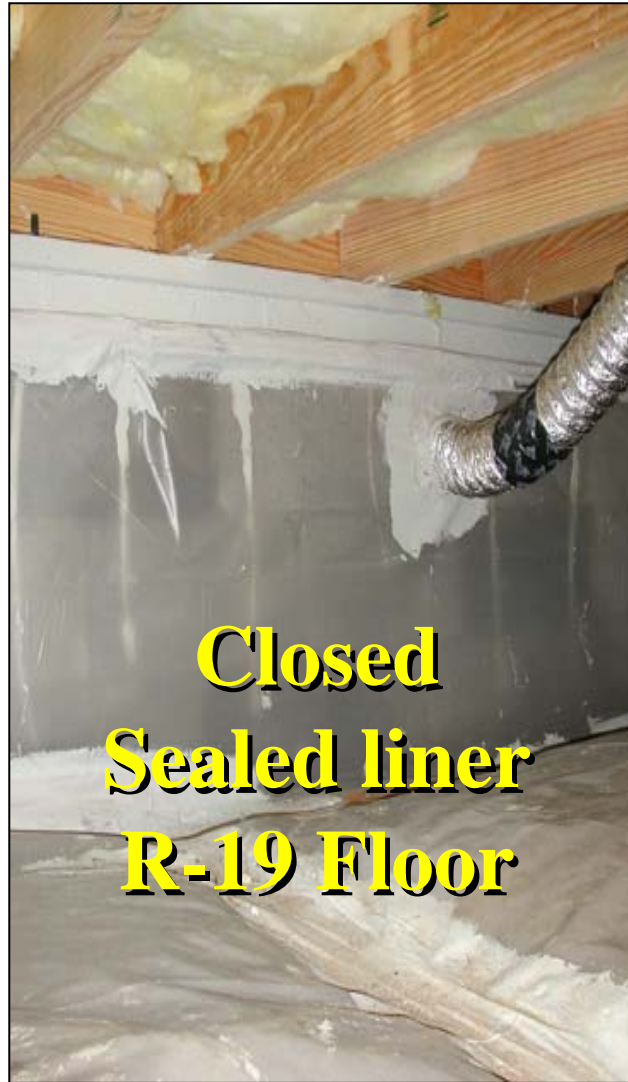
**Closed
Sealed liner
R-19 Floor**

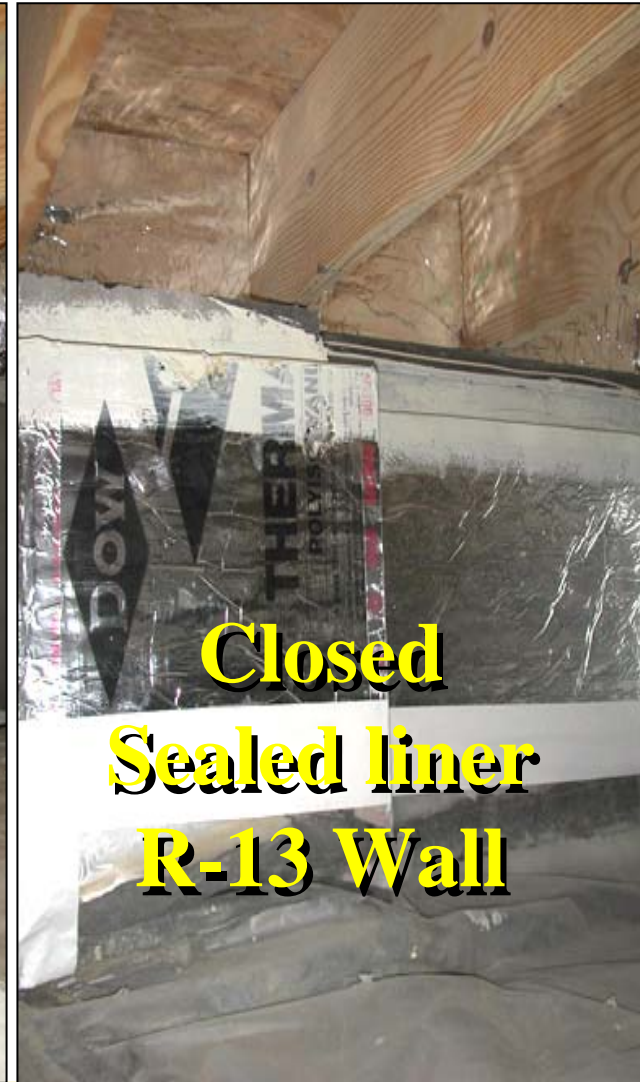
**Closed
Sealed liner
R-13 Wall**

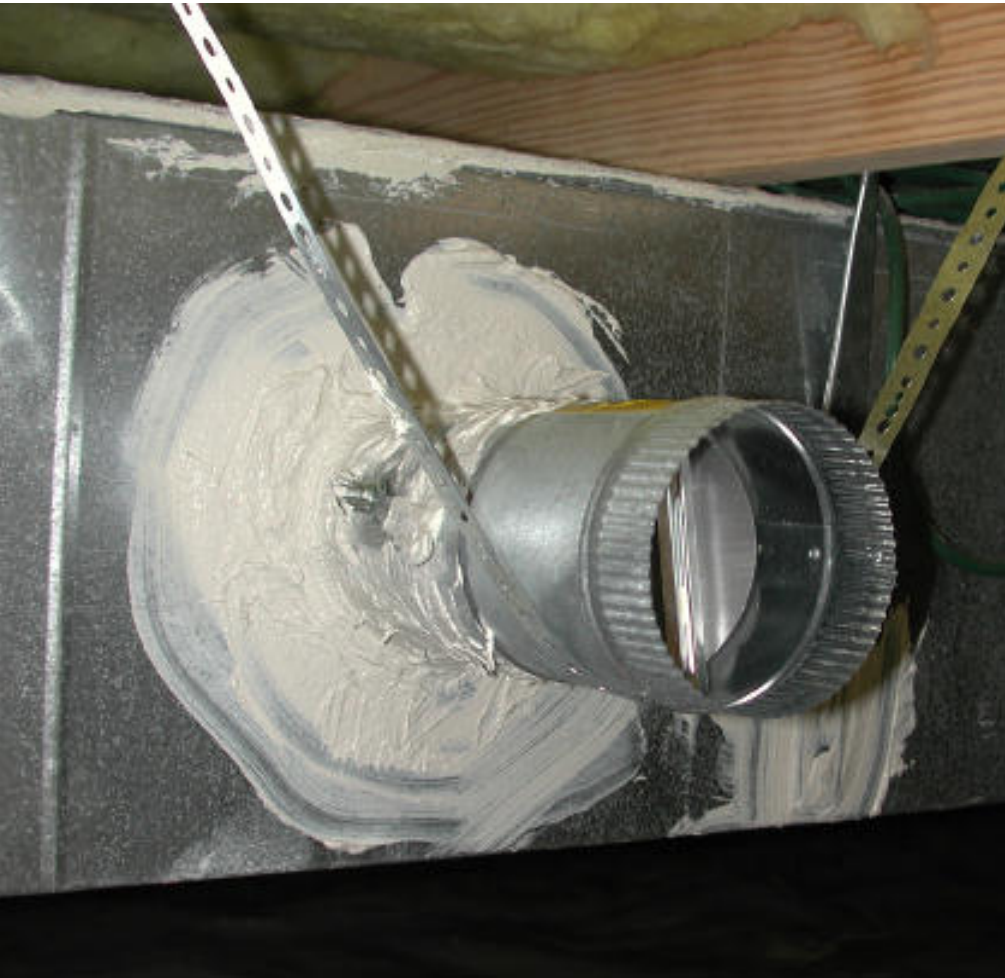
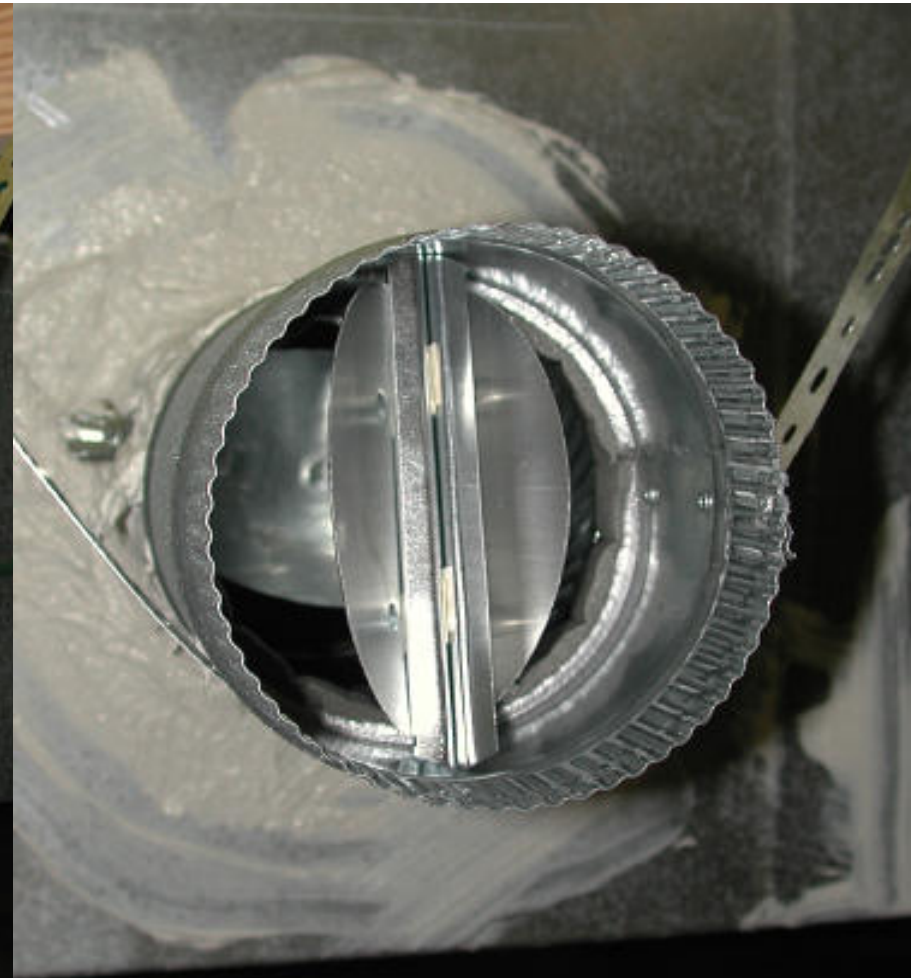
Crawl Space Supply Air Duct

- Sub-metered all heat pumps
- Air-sealed all floors and crawl space ductwork
- Re-measured component leakage
- Provided HVAC supply air in closed crawls
(1 cfm per 30 square feet)
- Modified closed crawl space insulation systems

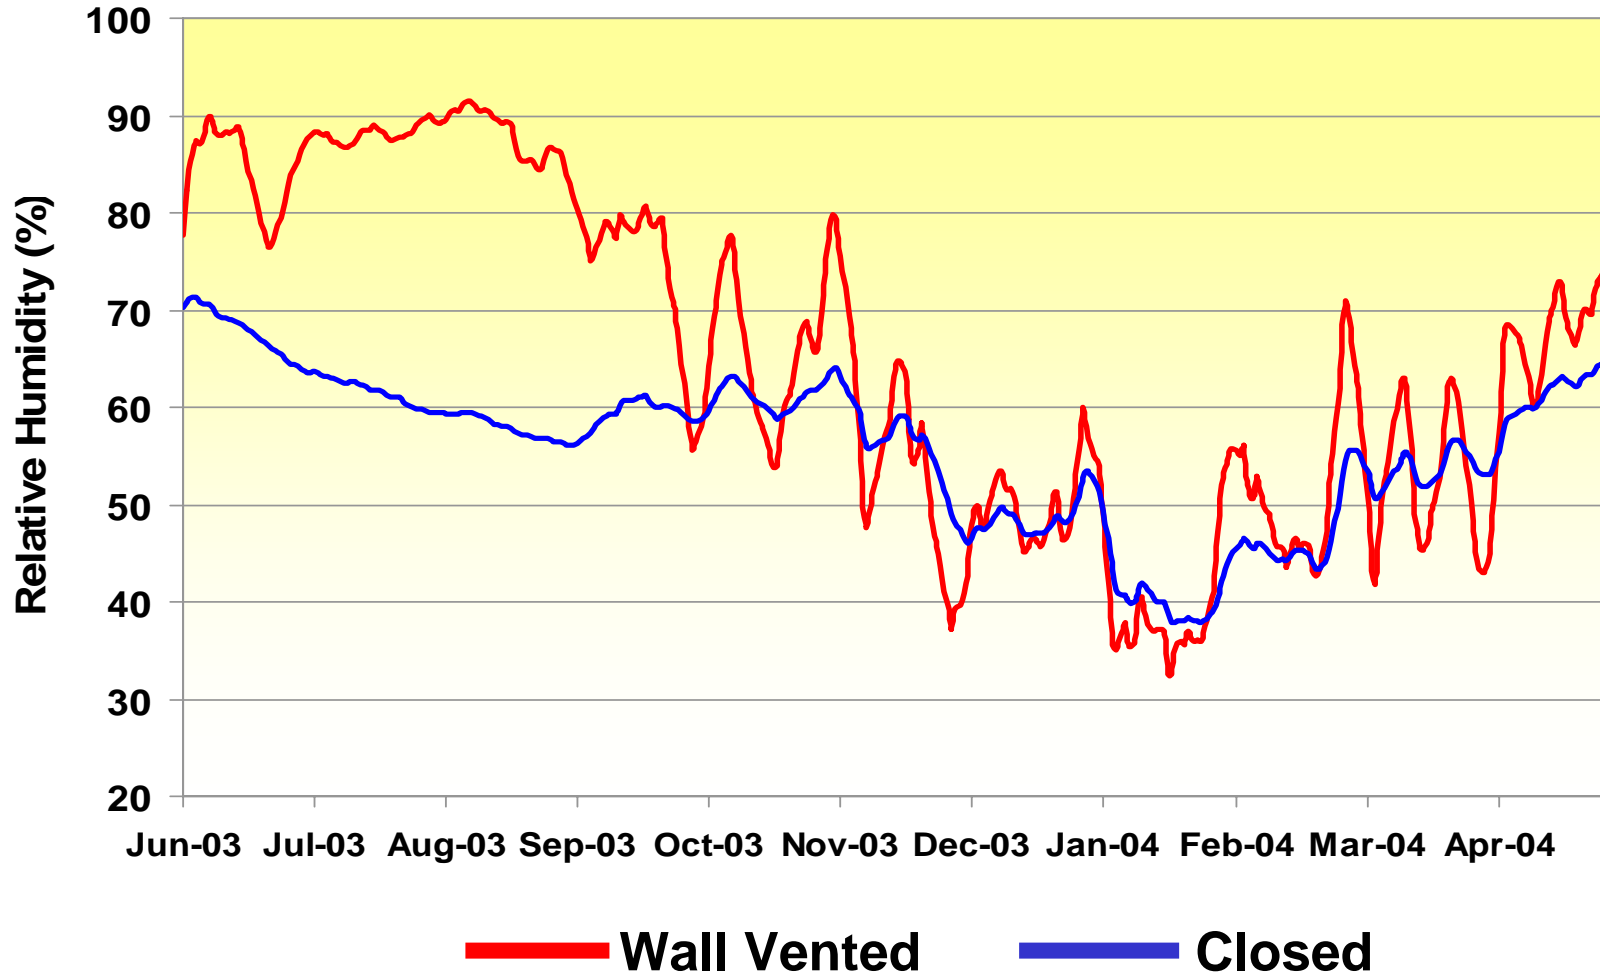
Phase II Crawl Space Relative Humidity

<u>Percentage of Time</u>	<u>2002</u>		<u>2003</u>	
	<u>Vented</u>	<u>Closed</u>	<u>Vented</u>	<u>Closed</u>
Above 90% RH	0%	0%	23%	0%
Above 80% RH	39%	0%	86%	0%
Above 70% RH	79%	0%	98%	5%
Above 60% RH	94%	0%	100%	64%
Above 50% RH	100%	100%	100%	100%
